Project No. TS - 7618

Preliminary Arborist Report

Re: City of Shoreline 1st Ave NE Sidewalk Project

Date: April 13, 2021

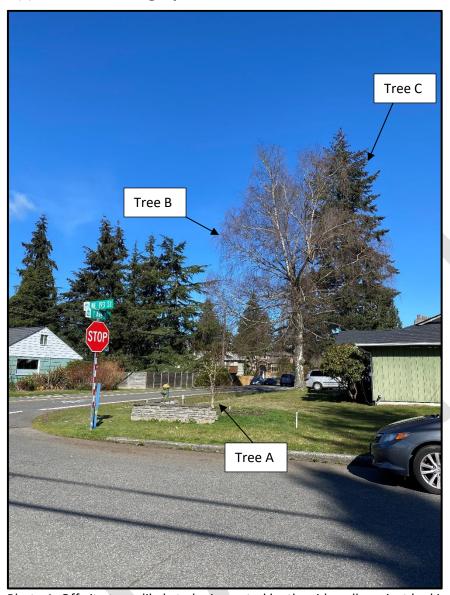
Photo 1. Off-site trees likely to be impacted by the sidewalk project looking northwest.

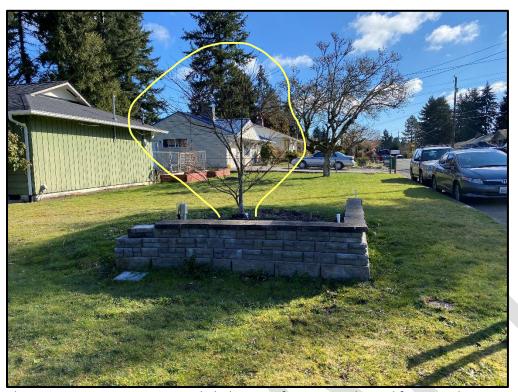
Tree A is a Japanese maple (*Acer palmatum*) below significant size (Photo 1). Due to infrastructure conflicts, the property owner has decided to transplant the tree. Coordinate with the property owner to ensure that the tree is transplanted prior to site work beginning. I recommend the homeowner provides supplemental irrigation and applies a 4-inch layer of arborist wood chips within the dripline after transplant to help mitigate transplant stress. Tree Solutions can provide additional transplant specifications if needed.

Photo 2. Tree A, a Japanese maple below significant size. Planned for transplant prior to work.

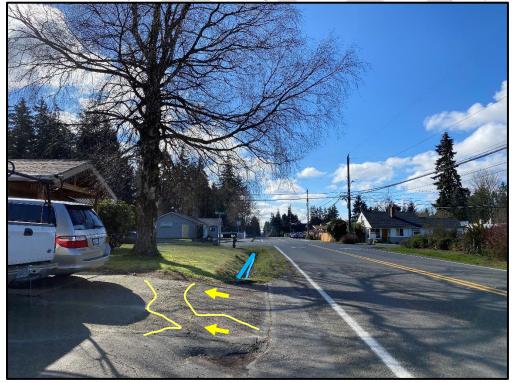
European birch trees in our region, particularly those experiencing drought stress, are highly susceptible to bronze birch borer (*Agrilus anxius*) infestation which may kill the tree. I did not observe evidence of advanced bronze birch borer activity in this tree, but I did observe several infected trees in the

neighborhood to the east. It is likely that this birch is taking up water from the existing ditch during storm events and is not experiencing the drought stress common in the region. Because stormwater will be routed away from the root system of this tree, this tree will likely experience increased drought stress. I recommend installing 4-inches of arborist wood chip mulch throughout the dripline (or as far as aesthetics allow) to help maintain soil moisture and temperature. Additionally, supplemental irrigation should be provided during construction to mitigate stress from construction impacts.

Photo 3. Tree B, a significant European birch. Note proximity to existing ditch (blue) and root conflicts (yellow).

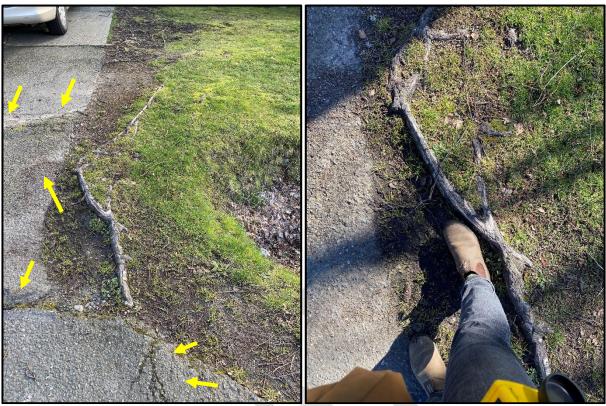
Tree B is a European birch (*Betula pendula*) in good health and structural condition. I observed surface roots in the yard, growing into the ditch, and below the pavement of the driveway to the north (Photo 4). A new storm drain will be installed in the existing ditch, and the existing storm infrastructure and asphalt within the TPZ will be removed and replaced.

Photo 4. Large diameter surface root from Tree B, a European birch. Efforts should be made to preserve and work around large diameter roots. Note the conflicts with existing driveway identified with yellow arrows.

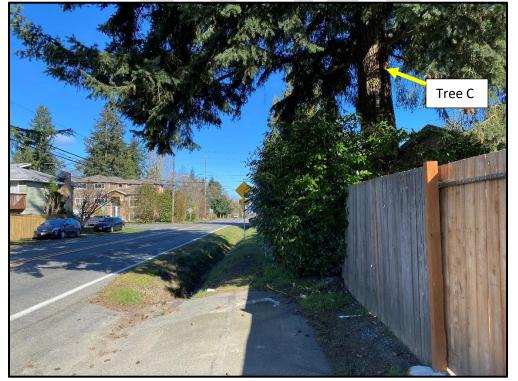
Tree C is a Douglas-fir (*Pseudotsuga menziesii*) tree that likely qualifies as a landmark tree; its diameter should be confirmed in coordination with the adjacent property owner. The existing storm drain infrastructure and asphalt within the TPZ of this tree will be removed and replaced (Photo 5). This work has potential to heavily impact the tree and should be performed following the specifications and recommendations provided within this report.

Photo 5. Tree C, a Douglas-fir tree that may qualify as a Landmark tree. Existing ditch and asphalt fall within the dripline and recommended tree protection zone.

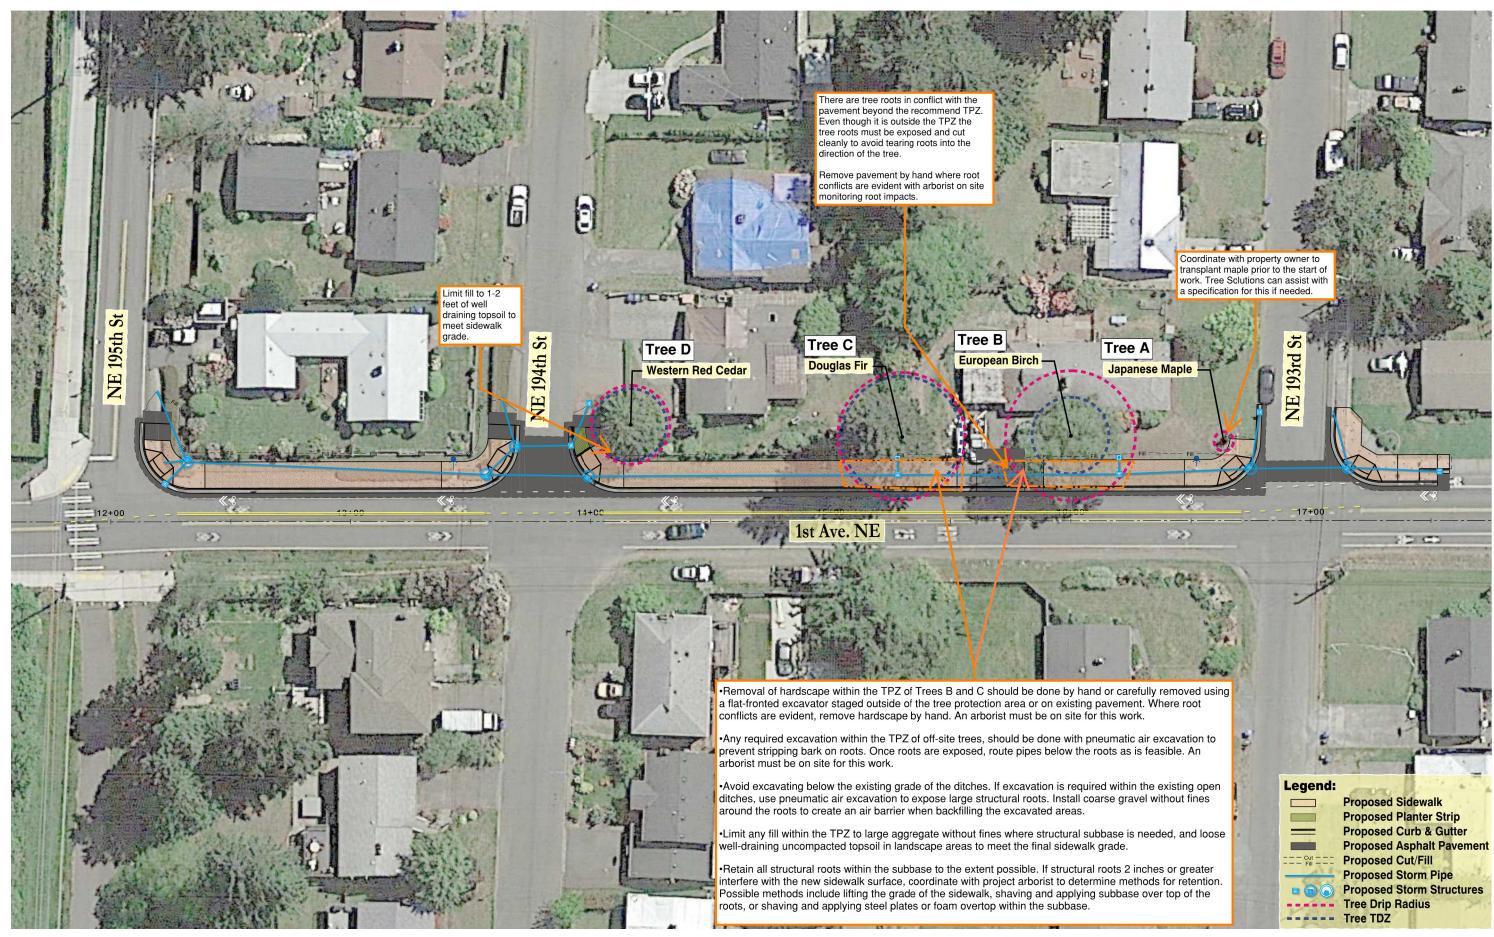
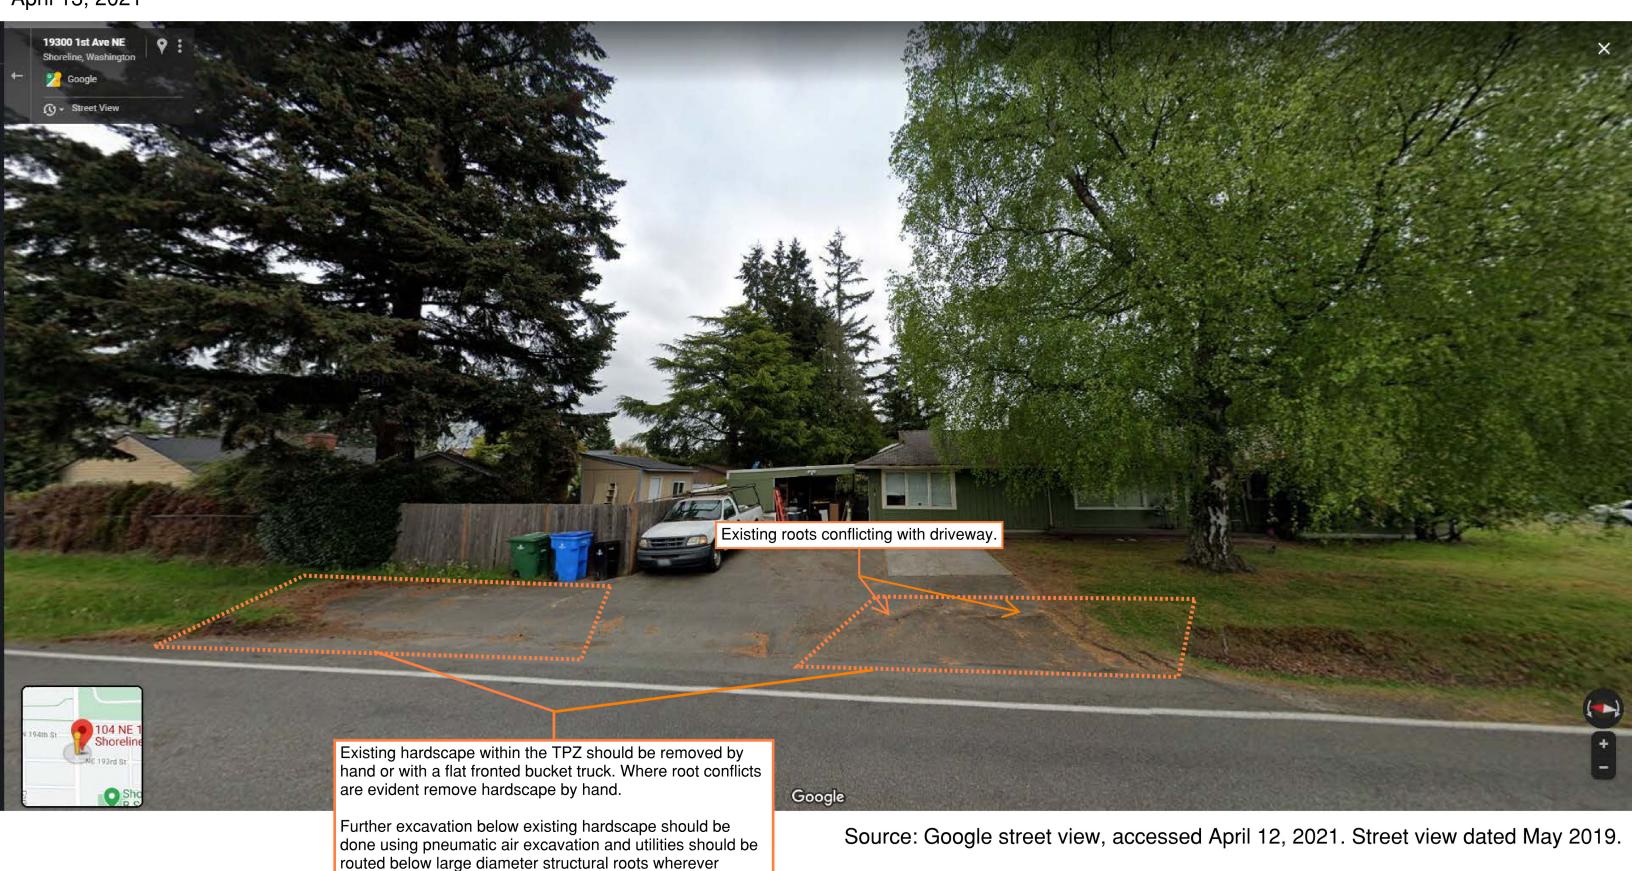
Tree Solutions Inc. Shoreline Sidewalk Project - DOWL A. Starbird April 13, 2021

Arborist monitoring will be required.

I have indicated areas where arborist monitoring and alternative excavation measures will be necessary on the attached annotated exhibit.
